DNA STR ANALYSIS

TROUBLESHOOTING GUIDE

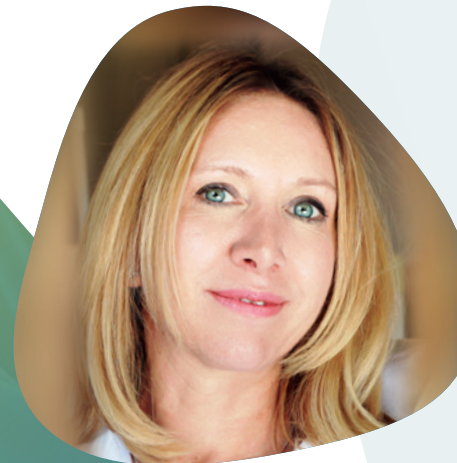
Troubleshooting STR Analysis

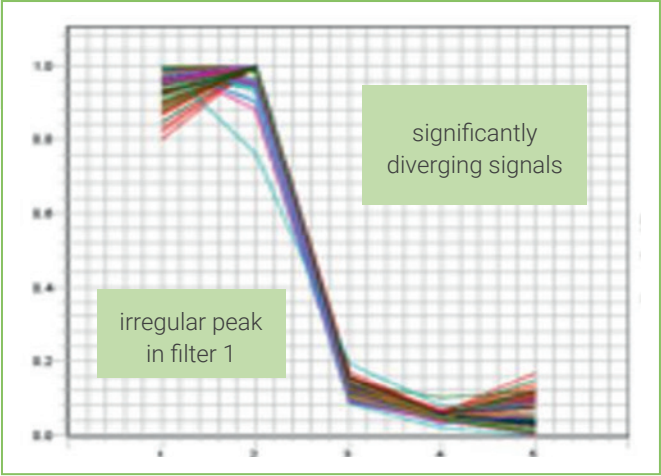
🔔 Inspect the calibration spectra yourself.

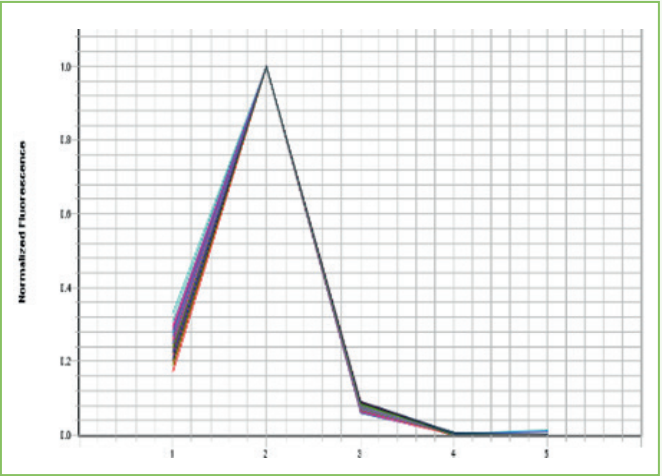
Plate sealed with recommended **MicroAmp® optical adhesive film** (Applied Biosystems)

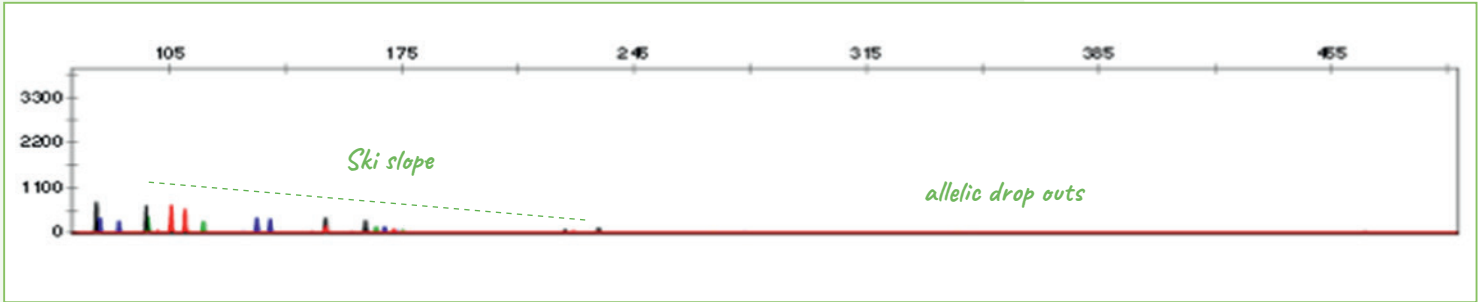
PowerPlex® Fusion System. Amplified product was separated using an Applied Biosystems® 3500 Genetic Analyzer (1.2 kV, 24-second injection).

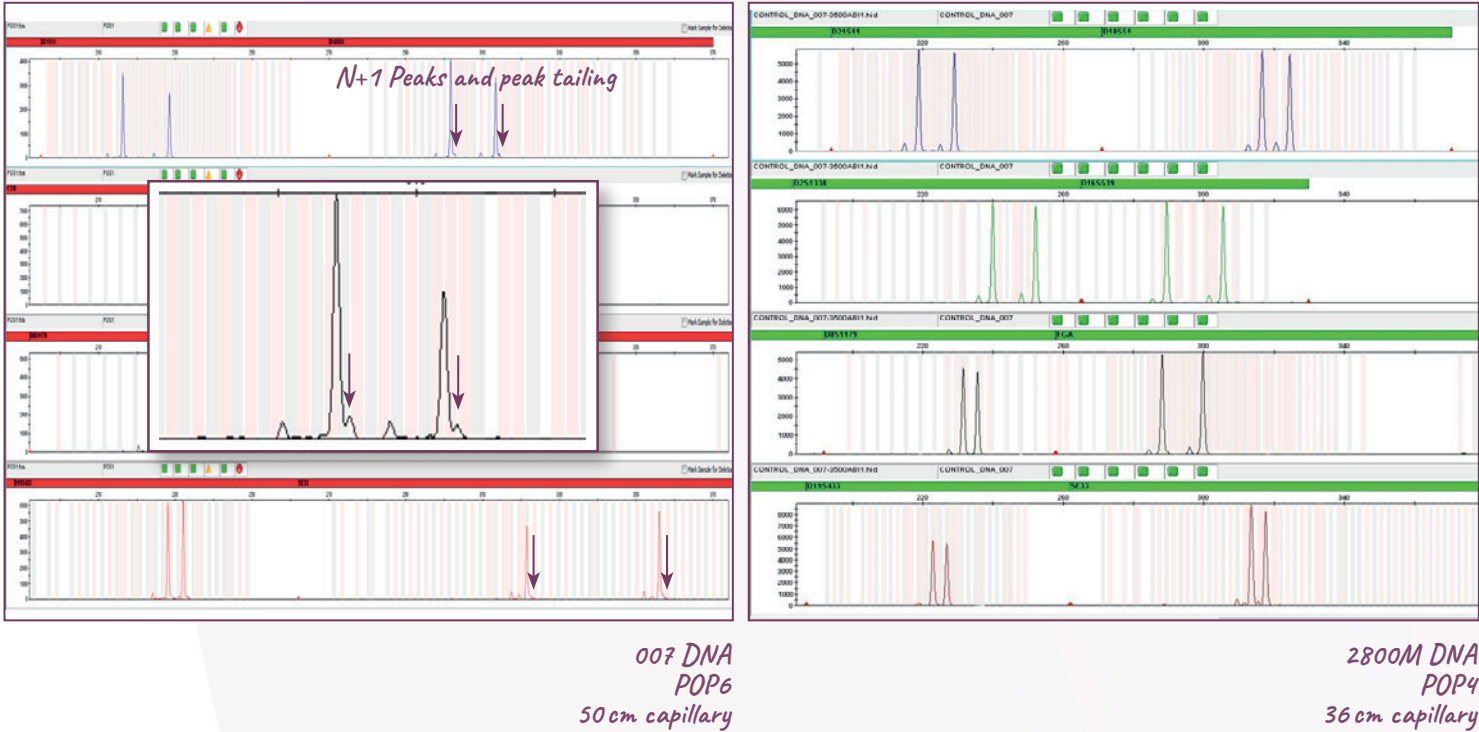
PowerPlex® ESX 17 Fast System. Amplified products were separated using an Applied Biosystems® 3500 Genetic Analyzer (1.2 kV, 24-second injection).
